# Durability of sisal fiber-reinforced mortar with glass powder as cement substitute in aggressive environment

## Abstract

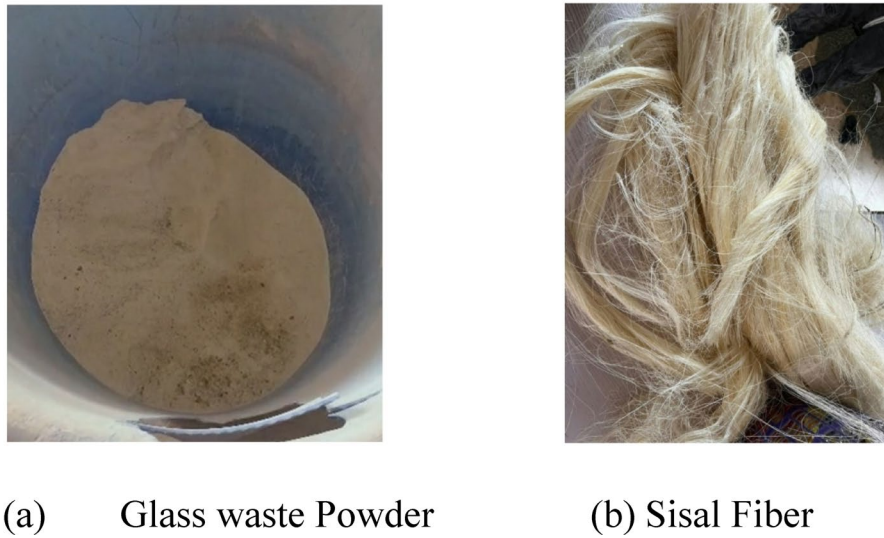
**Fig. 1** Materials**Table 1** Mix proportion

D1193-20 was used in all mix preparations. Waste glass was collected from restaurants, bars, and shebeens in Ilorin; after thorough cleaning and manual sorting to remove non-glass materials, it was mechanically crushed, ground to fine particles using a mechanical grinder, and sieved to pass through a 90-micron sieve. This ensured a uniform particle size suitable for use as a supplementary cementitious material in mortar production, with the grinding carried out at the Civil Engineering Department Laboratory, LAUTECH, Ogbomosho. Sisal fibers were sourced in Ilorin, where they were cleaned, sun-dried, manually separated for uniformity, and trimmed into 30 mm lengths before use in the concrete mix. Finally, magnesium sulfate heptahydrate ( $\text{MgSO}_4 \cdot 7 \text{H}_2\text{O}$ ), AR grade with a purity of  $\geq 99\%$ , was locally sourced from Irebamidele Chemical Store in Ilorin and supplied in 500 g bottles Fig. 1.

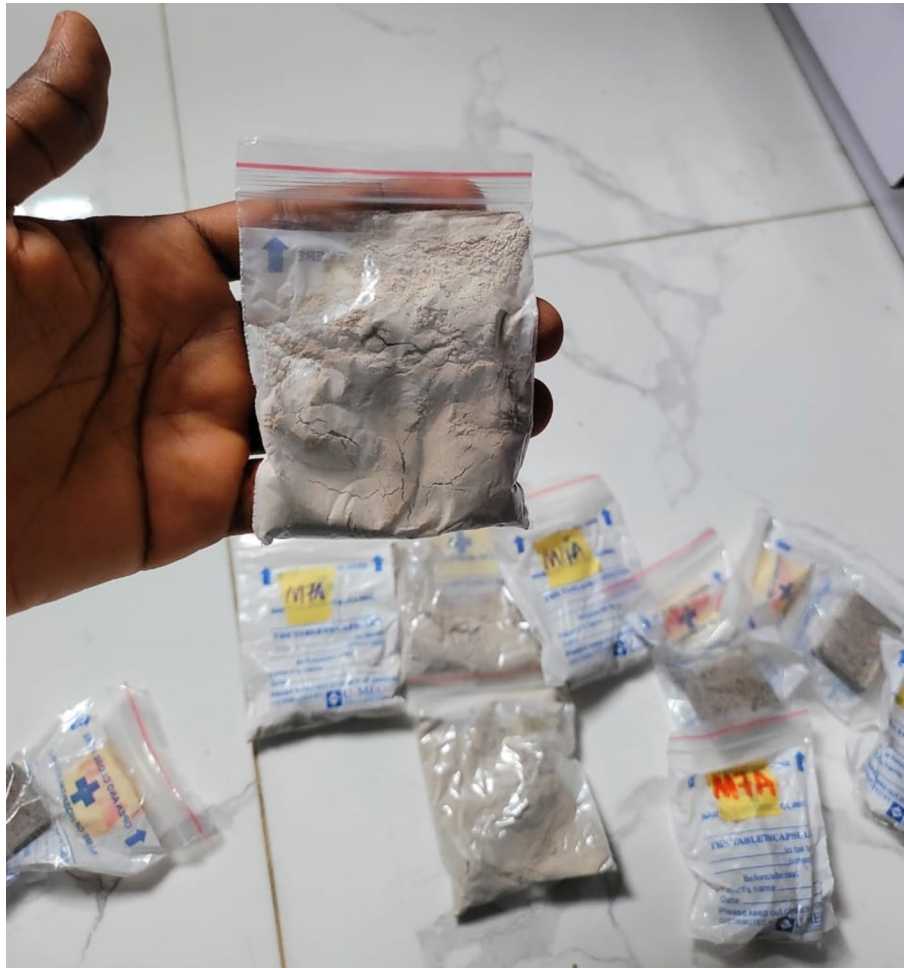
**Fig. 2** Powdered samples

X-ray fluorescence (XRF), X-ray diffraction (XRD), and scanning electron microscopy (SEM) were conducted to evaluate the chemical composition, crystalline phases, and microstructural morphology of the mortar and glass powder samples. Figure 2 presents the powdered mortar samples used in these tests.

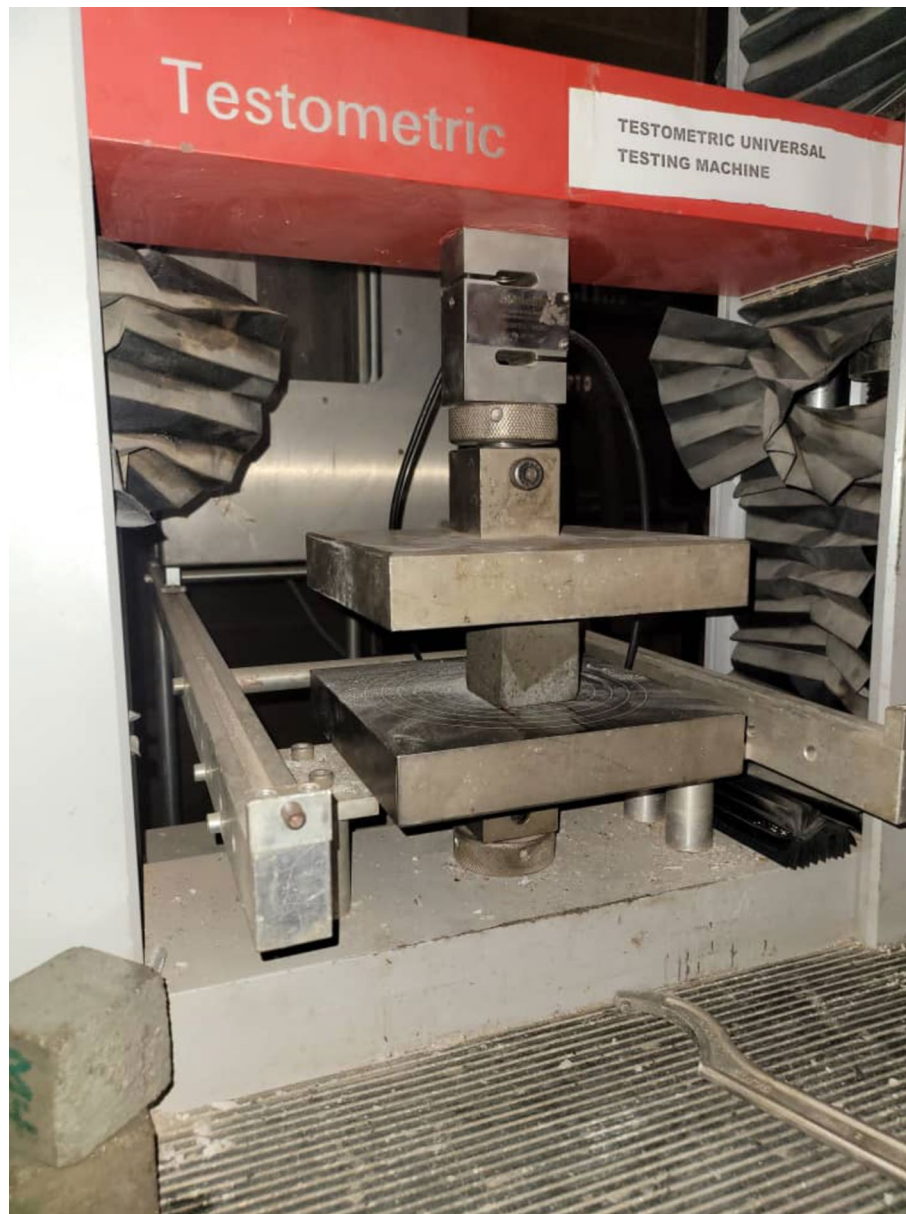
**Fig. 3** compressive strength test

The compressive strength test was performed to determine the load-bearing capacity of the modified mortar. Standard  $50 \times 50 \times 50$  mm cubes were prepared by thoroughly mixing the constituents, casting them into molds, and compacting the mix. The specimens were cured in water for 7, 28, 56, 90, and 120 days. After each curing period, the samples were removed, surface-dried, and tested using a Universal Testing Machine (UTM) at the University of Ilorin. The load was applied gradually until failure, and the peak load was recorded in accordance with ASTM C109 (2021), as shown in Figs. 2, 3.

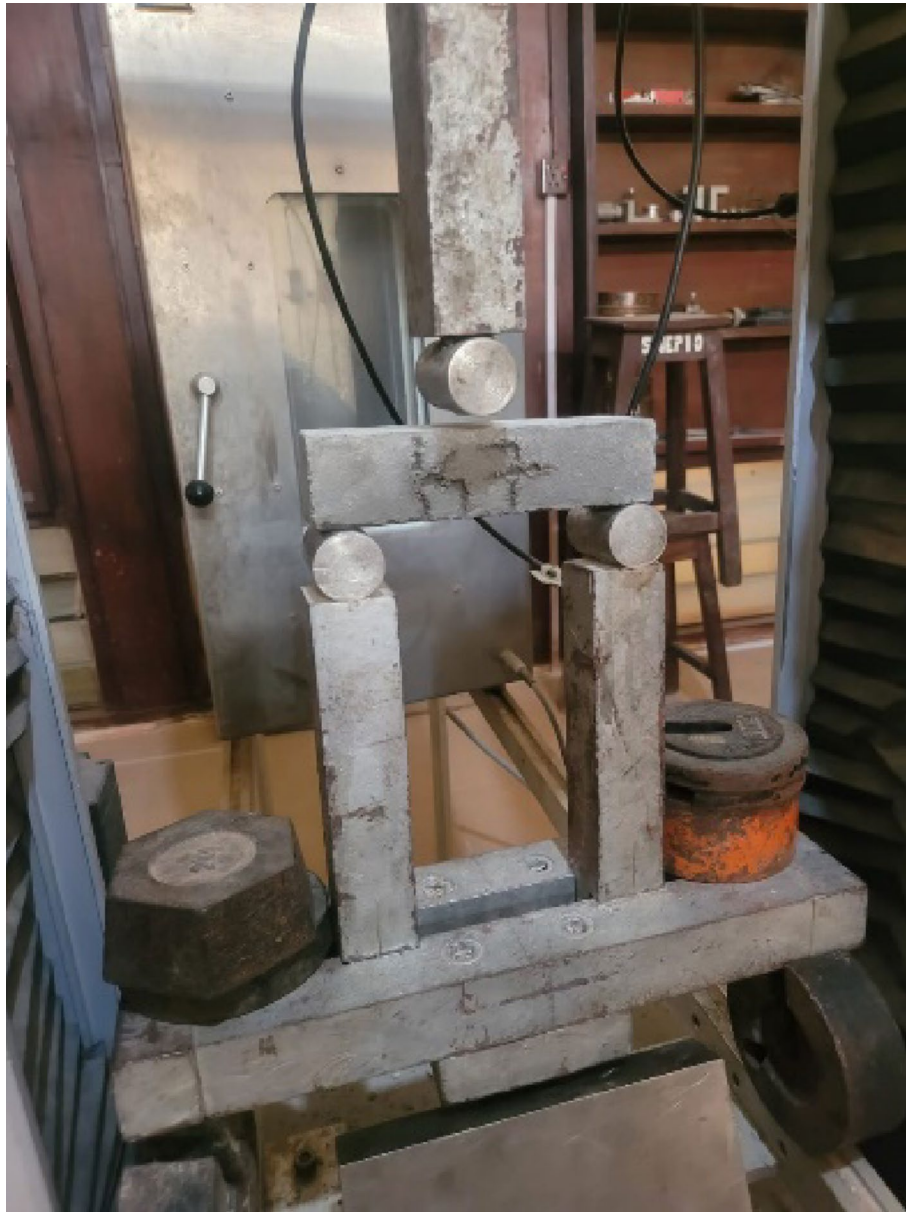
**Fig. 4** flexural strength test

The flexural strength test assessed the mortar's bending resistance using prismatic specimens of size  $40 \times 40 \times 160$  mm, cured for the same durations. The test was conducted under a three-point loading configuration using a UTM, following ASTM C348 (2002). Each beam was placed on two support rollers, and a central load was applied until fracture occurred. The maximum breaking load was recorded and used to calculate flexural strength. This test provided insights into the contribution of sisal fibers and glass powder to tensile performance and crack resistance of the mortar under flexural stress (Fig. 4).

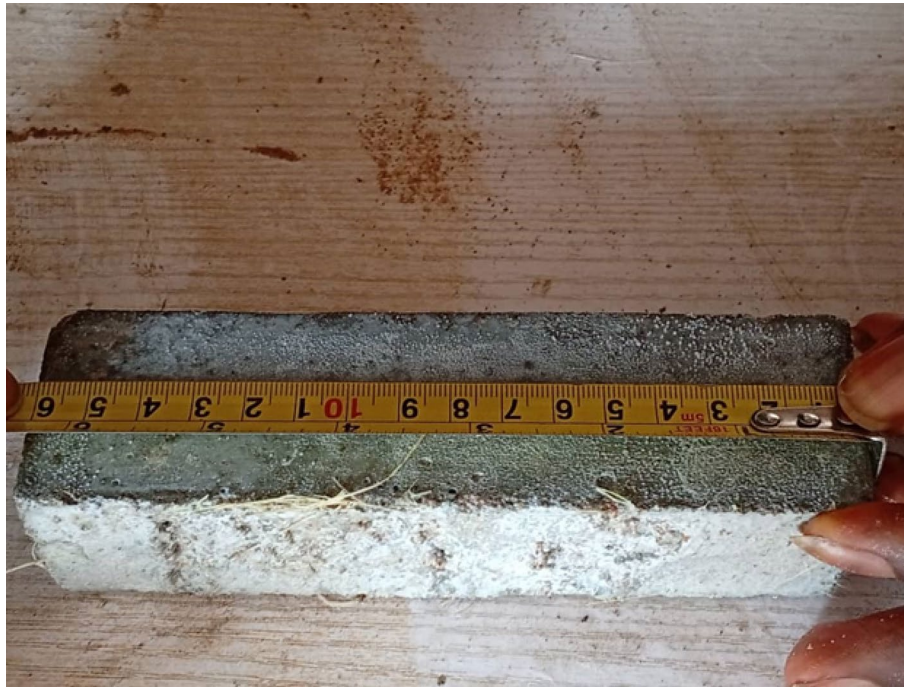
**Fig. 5** Measuring length change after  $\text{MgSO}_4$  exposure

prepared 5% magnesium sulfate ( $\text{MgSO}_4 \cdot 7 \text{H}_2\text{O}$ ) solution, made by dissolving 50 g of  $\text{MgSO}_4$  in 1 L of distilled water. The solution was maintained at  $23 \pm 2^\circ\text{C}$ , with pH controlled between 6.0 and 8.0. Each specimen was exposed at a solution-to-mortar volume ratio of  $4.0 \pm 0.5$ , typically requiring 625–800 mL per bar. Deterioration was monitored at 30, 60, and 90 days by visual inspection for cracks and scaling, followed by compressive strength testing. A control group was submerged in tap water for comparison. This test simulated long-term exposure to aggressive environments and evaluated the durability of the modified mortar (Fig. 5).
